Chamberlain Creek Coho Passage Design Project 100% Basis of Design Memorandum

CDFW Agreement #Q2010525
PWA Report No. 221038201
May 2023

Prepared by:
Pacific Watershed Associates Inc.
P.O. Box 4433, Arcata, CA 95518
(707) 839-5130
www.pacificwatershed.com

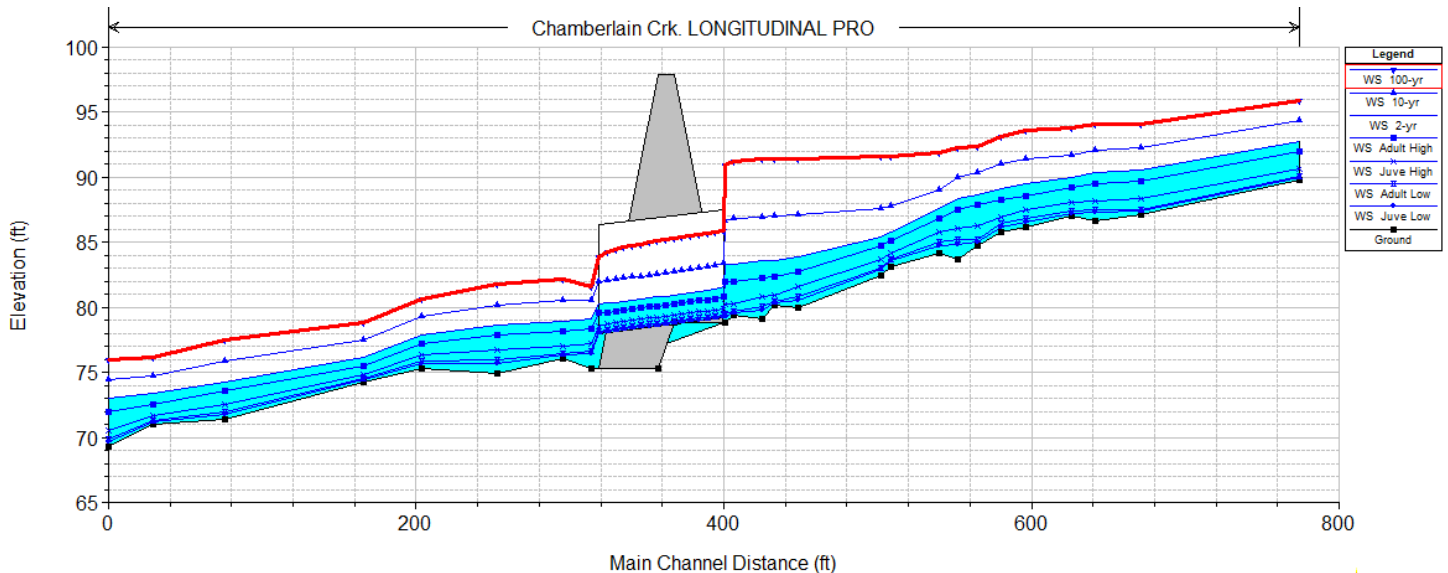
Figure 4. HEC-RAS profile of existing flows along Chamberlain Creek

As previously discussed, the existing conditions at the project site, including culvert hydraulics, were modeled using HEC-RAS. All of the flows mentioned in Section 5.3 were modelled, but for discussion and image clarity purposes, only a few targeted flows are shown in the following figures. The 100-year, 10-year, 2-year, high and low fish passage flows for adults and juveniles are shown below. A profile of the project reach, including the water surface elevation for various flows through the existing culvert, is shown in Figure 4.

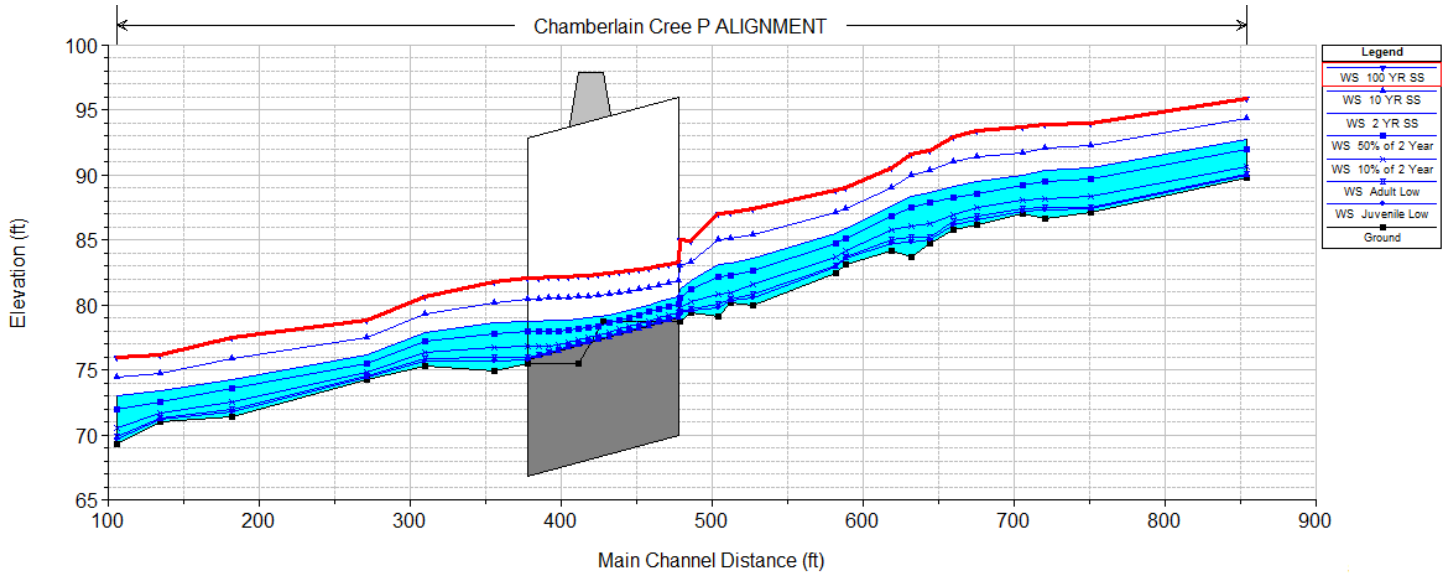
Figure 9. HEC-RAS profile of proposed conditions along Chamberlain Creek

The results of the modeled proposed conditions show restored hydraulics when the realigned Chamberlain Creek is conveyed through the 26 ft diameter round culvert. Figure 9 shows the realigned profile through the proposed culvert and includes water surface elevations for a variety of flow regimes.

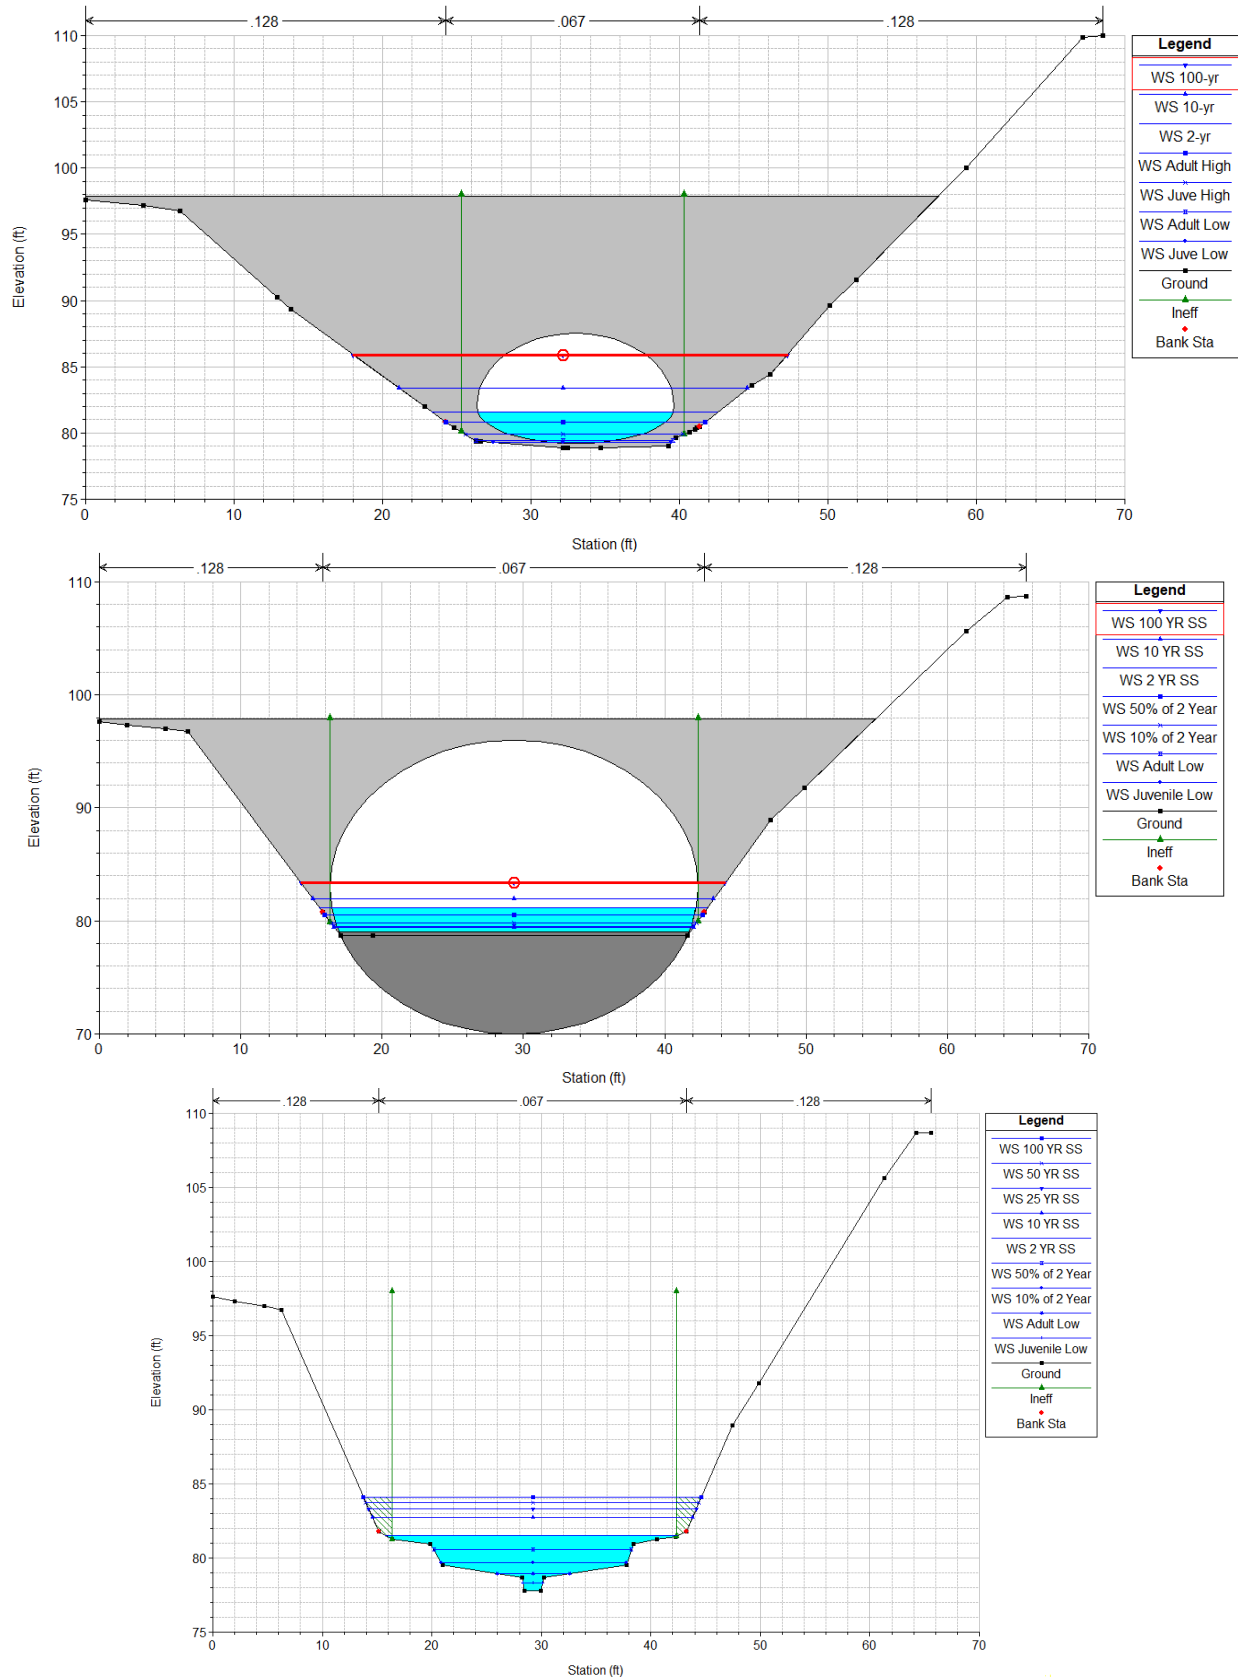
Figure 10. HEC-RAS inlet cross sections for existing (top) and proposed (middle/bottom) conditions

In the model, peak flow conditions are simulated with a restricted culvert geometry that approximates the ESM as a flat surface but to accurately portray the low-flow channel, the lower flows were simulated as an open channel without a culvert. Ineffective-flow areas were created to emulate the walls of the culvert as is common practice when analyzing low-flow conditions for fish passage projects with natural bathymetry. A cross sectional comparison between the existing structure inlet (top image) and the proposed structure inlet at various flows is shown in Figure 10. For reference, the 2-year flood is filled in with light blue, the 100-year flood is the red line, and all of the other flows have different markers along the dark blue profile lines. The peak flood conditions in the proposed model are shown with a closed culvert (middle image), while the exceedance flows for the proposed conditions model are shown as an open channel (bottom image). The details of that low-flow channel, and other important information regarding ESM installation like bank-line rock and the aforementioned ribs, are specified in the Plans on Sheet 7 of Appendix A.

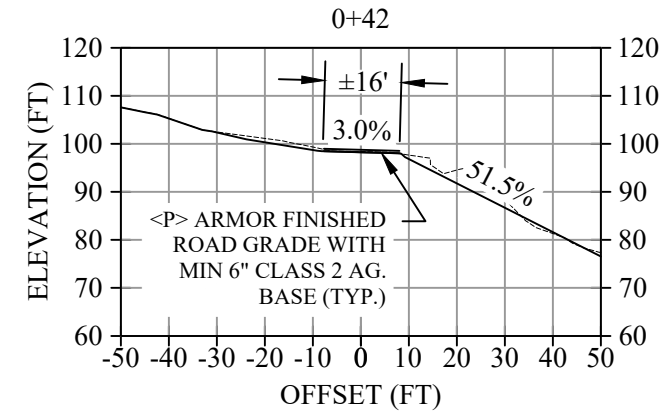
3 SECTION VIEWS
 6 CHAMBERLAIN ROAD IMPROVEMENTS
 HORIZONTAL, VERTICAL SCALE: 1" = 40'

- NOTE:
1. ALL SECTION VIEWS LOOK NORTH ALONG ROAD CENTERLINE ALIGNMENT.
 2. AGGREGATE BASE MATERIAL SHALL BE CLASS 2 BASE OR LOCALLY AVAILABLE CRUSHED ROCK, CONFORMING TO SECTION 26-1.02B & C OF CALTRANS STANDARD SPECIFICATIONS (2022).
 3. ROAD GRADING SHALL COMPLY WITH CALTRANS STANDARD SPECIFICATIONS SECTION 19.

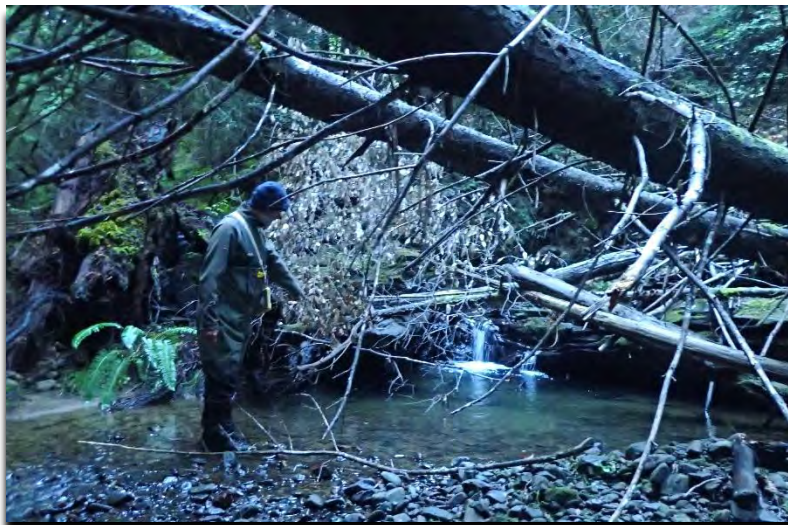
Photograph 2. Looking upstream at Habitat Unit #33. A primary pool with a maximum depth of 3.5 feet. Also the upstream survey end for the project reach.

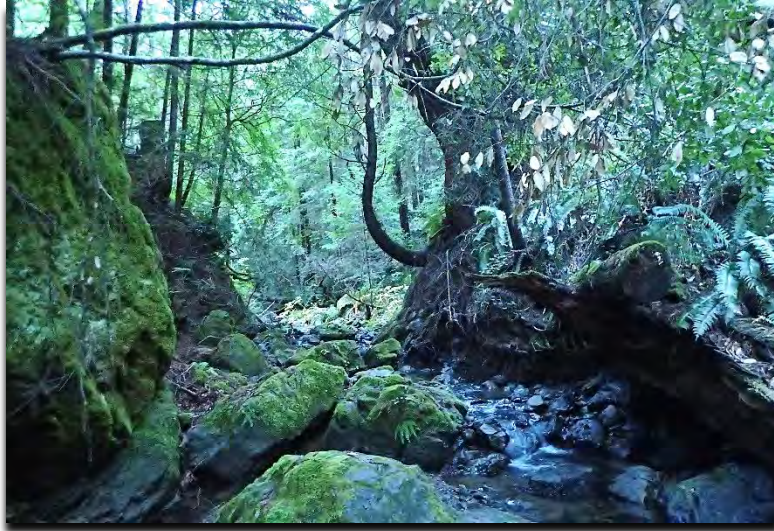
Photograph 3. Looking upstream at Habitat Unit #16. Showing boulders and bedrock within the channel forming, a step-run habitat type flowing into a secondary pool below.

channel above also included boulders in conjunction with the bedrock (Photograph 3) and distinct step-run habitats not found below the culvert.

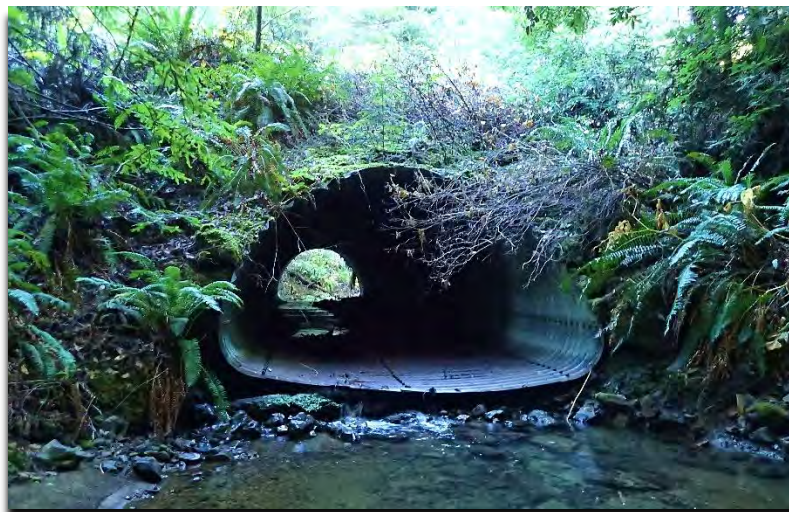
Photograph 4. Habitat Unit #13. Looking upstream at the culvert outlet and the upstream portion of the secondary pool at the outlet. This pool had a maximum depth of 1.75 feet.

Shallow pools bounded the culvert, both upstream and downstream (Photograph 4). These pools lacked any cover element or shelter value. Their formation appeared to be related more to bedrock than the culvert. The culvert is failing, and the bottom is nearly completely rusted through at about 1/3 up from the outlet (Photograph 4) with talus-like (angular) substrates aggraded within the pool head. This substrate accumulation is minimizing pool-jump depths and would limit access for adults to leap into the culvert and migrate to upstream habitats.
